Mt Buller Water Security Off- Stream Storage Project: Hydrological and Ecological Monitoring and Adaptive Management Program (HEMAMP) Condition 8 Assessment

**Prepared for Alpine Resort Victoria - Mount
Buller Mount Stirling Resorts**

Reference number: MBMSRMB1022

DATE: 22 May 2023

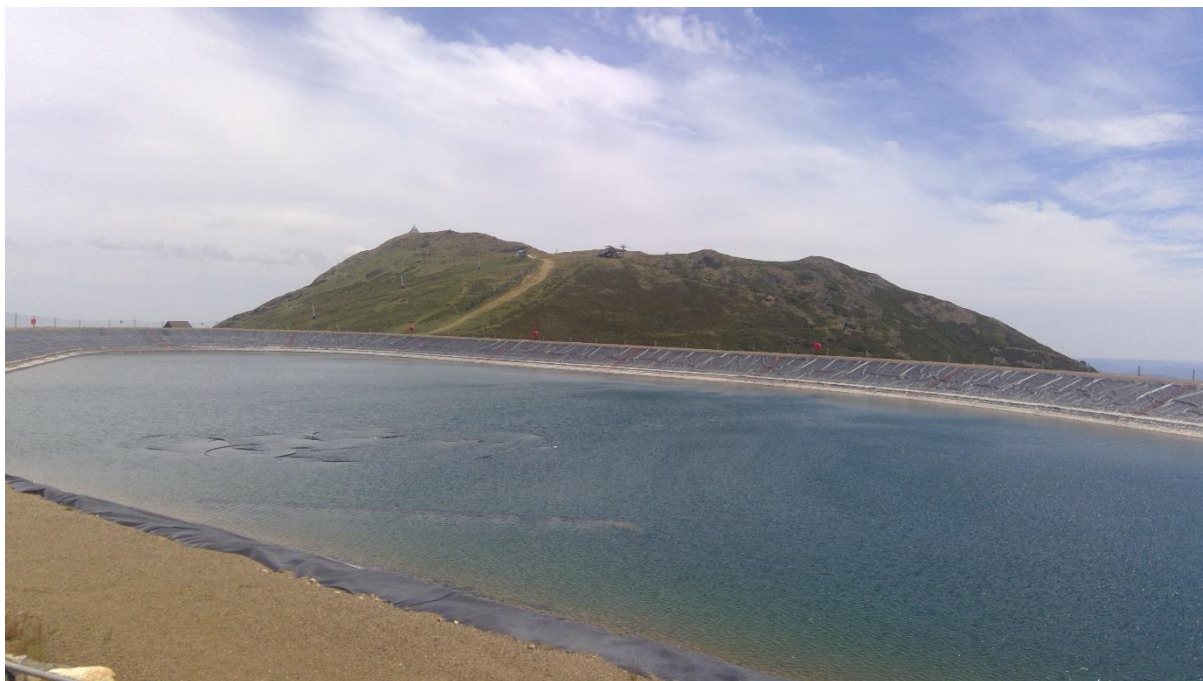
Figure 1. New water storage dam (Boggy Creek Reservoir) above alpine bog monitoring areas, Mt Buller

During 2019–2020, a large off-stream water storage facility was constructed at Mount Buller (Figure 1), between the summit and the village (Biosis, 2019c). As most of the Alpine Bog communities on Mount Buller are positioned downslope of the Project Construction Footprint, direct impacts to these communities were assessed as unlikely. However, indirect impacts because of hydrological changes upslope were considered possible, especially given Alpine Bogs are “*dependent on the maintenance of local hydrological conditions, particularly groundwater*” (Department of the Environment, 2015).

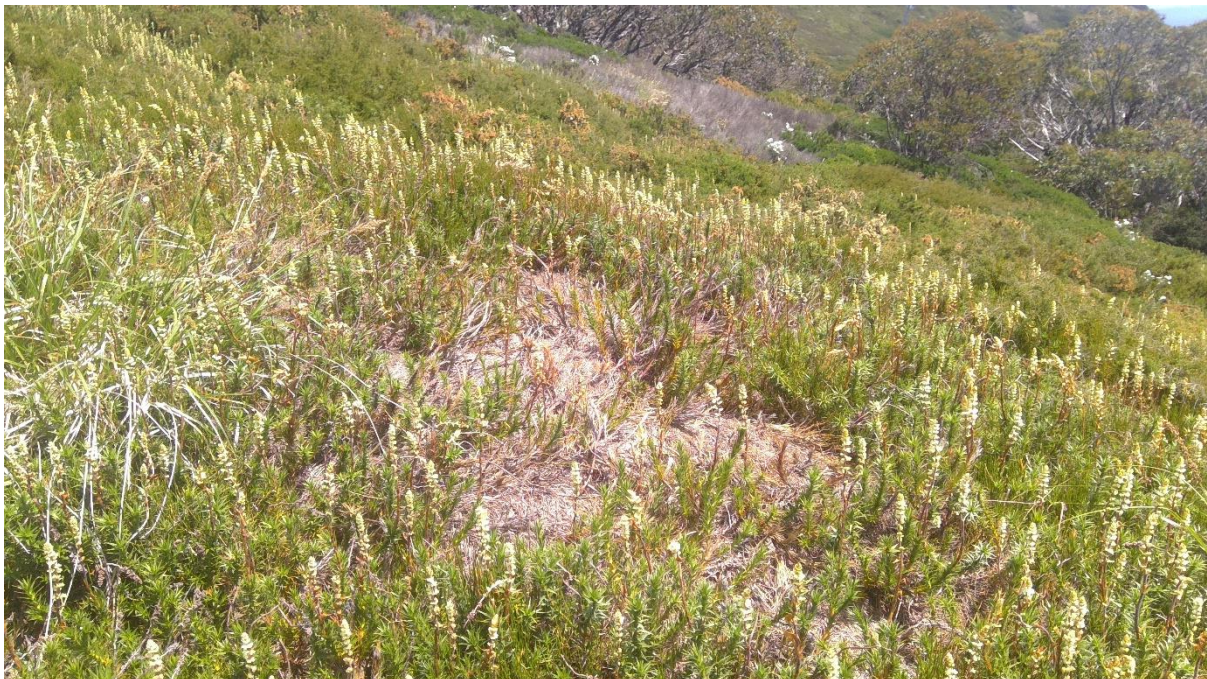
Ecological monitoring — Some small patches of dieback were observed within the indirectly affected Alpine Bogs (e.g. Figure 2 foreground), however ARV suggested this patch of dieback may have been present pre-construction, based on feedback provided by Biosis. A larger area (up to 25 m²) of dieback of adjoining non-bog vegetation was also observed (e.g. Figure 2 background), however, it is likely this dieback was also present in the area pre-construction. Non-bog vegetation dieback is discussed in detail in the Year 3 ecological monitoring report (Biosis, 2022b).

Figure 2. Example of small areas of dieback observed with the indirectly affected Alpine Bog (11.2) in the foreground, with dieback of adjoining non-bog vegetation in the background (facing west). Both patches were reported as being observed pre-construction.

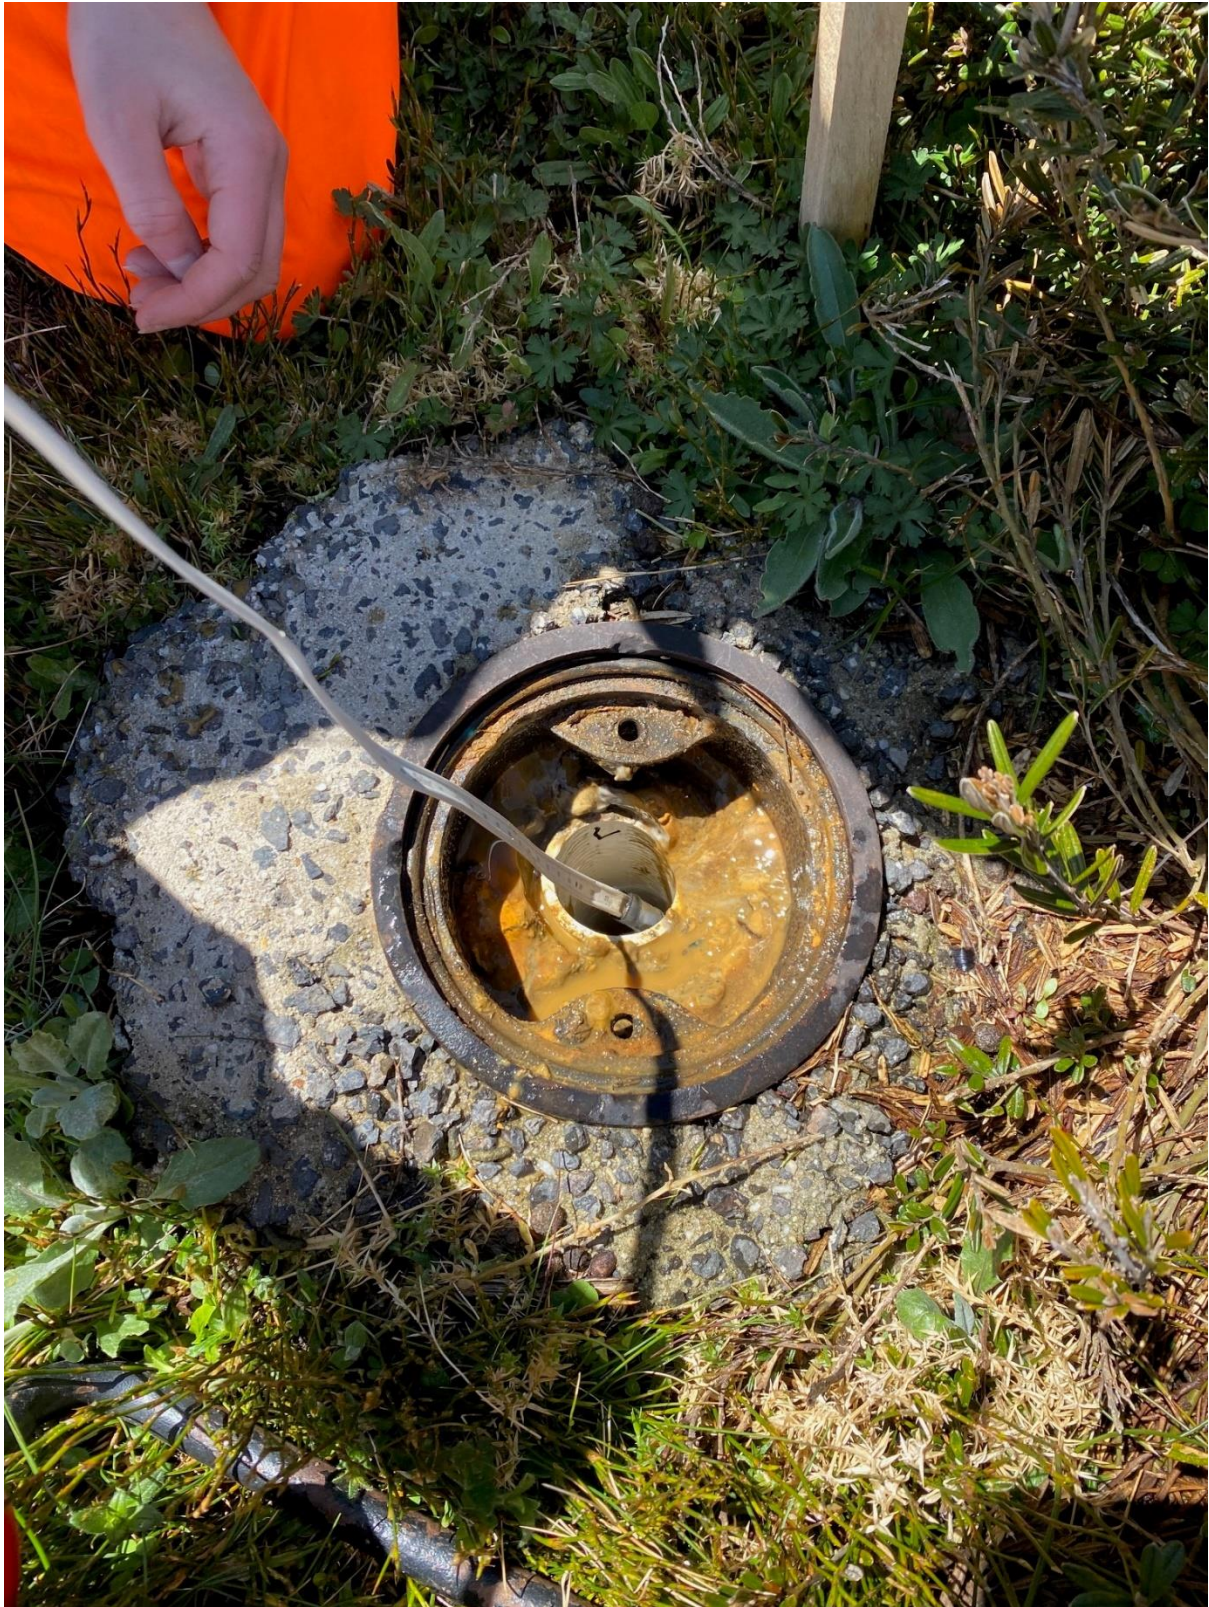
Hydrological monitoring — Several groundwater boreholes were observed during the site visit (e.g. Figure 3). During the site meeting, the collection of groundwater depth and surface water flow data for input into the hydrological model as part of the ‘feedback loop’ was discussed. Since 2021, hydrological data has been collected and it is the intention of the ARV to continue this data collection ongoing and at required intervals. ARV anticipates that this hydrological data will be analysed in the year 4 monitoring reports.

Figure 3. Example of a groundwater monitoring borehole being sampled (provided by ARV during the site meeting).

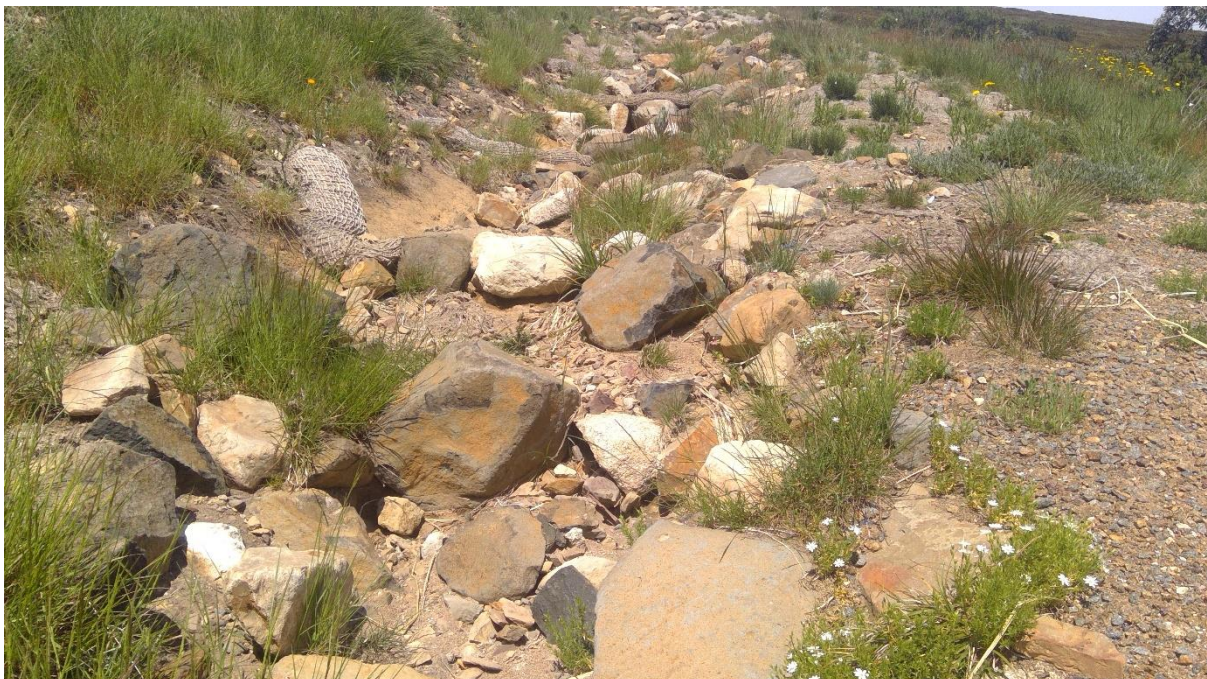
Drainage — Drainage lines were observed beside the dam and into the indirectly affected Alpine Bogs (e.g. Figure 4). These drainage lines included some sediment controls and boulders as energy dissipation measures. The aqueduct, with water present, was observed north of indirectly affected Alpine Bog 11.2 (Figure 5). The source of this water was discussed during the site meetings. Water in the aqueduct is sourced from a combination of naturally occurring ground and surface water, and potentially any excess flow through from below the dam and through the bogs. Sedimentation observed in the aqueduct was also discussed. Sedimentation has always occurred in the aqueduct, including pre-construction of the dam. Additional sedimentation was observed in the aqueduct during the dam construction and was associated with construction non-compliances. This collected, sediment was then flushed out and concentrated into Bog 6, contributing to impacts observed within this bog. Most of the sediment remaining in it now is old, remnant material.

Figure 4. Example of a drainage line beside (west of) the dam.

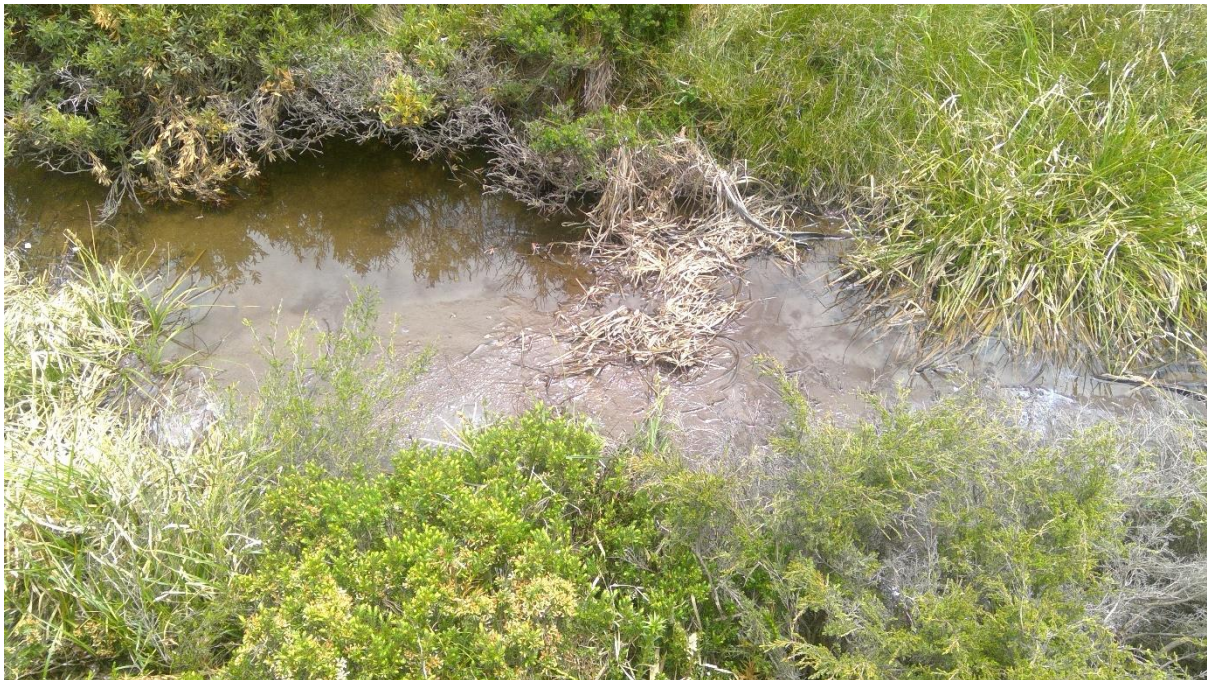
Figure 5. A section of the aqueduct north of indirectly affected Alpine Bog 11.2 with some evidence of sedimentation.

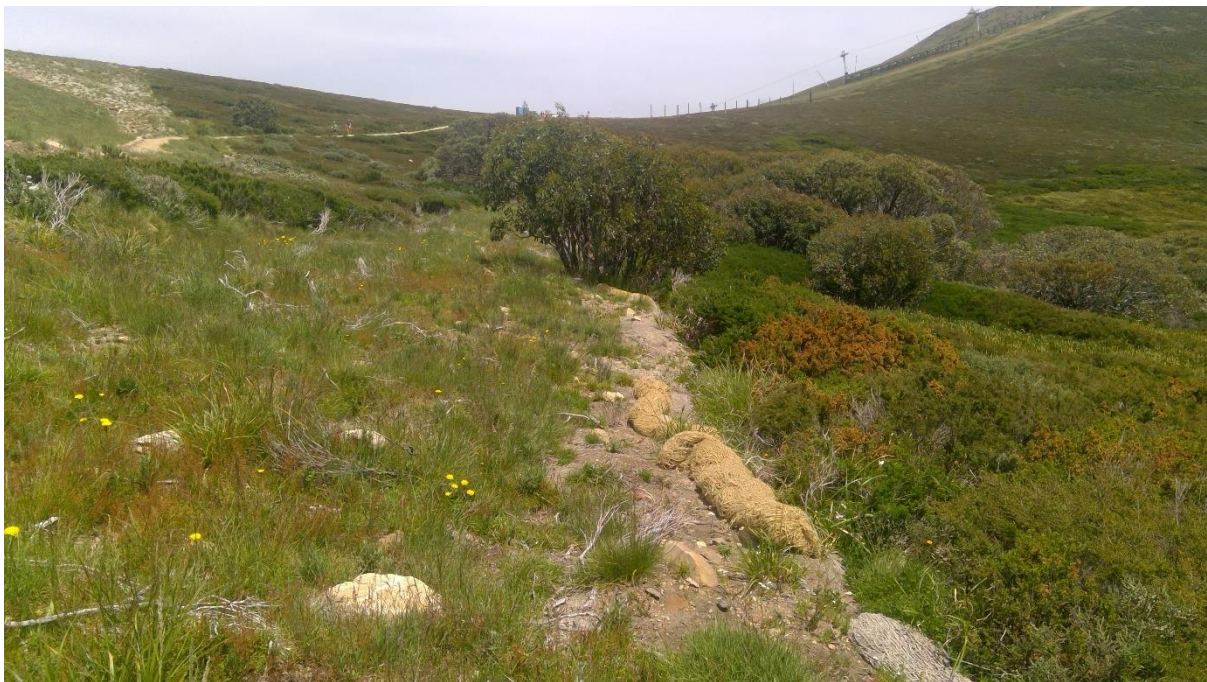
Environmental watering — The general location of the western extent of the environmental watering system was observed, including an area of indirectly affected Alpine Bog 4.2 which was removed (8 square metres) during the construction of the environmental watering system (Figure 6). The environmental watering discharge point infrastructure located between the dam and the Alpine Bogs was also observed.

Figure 6. Upper edge of indirectly affected Alpine Bog 4.2 where 8 m² of this bog was removed during the construction of the environmental watering system, with evidence of rehabilitation / revegetation observed.

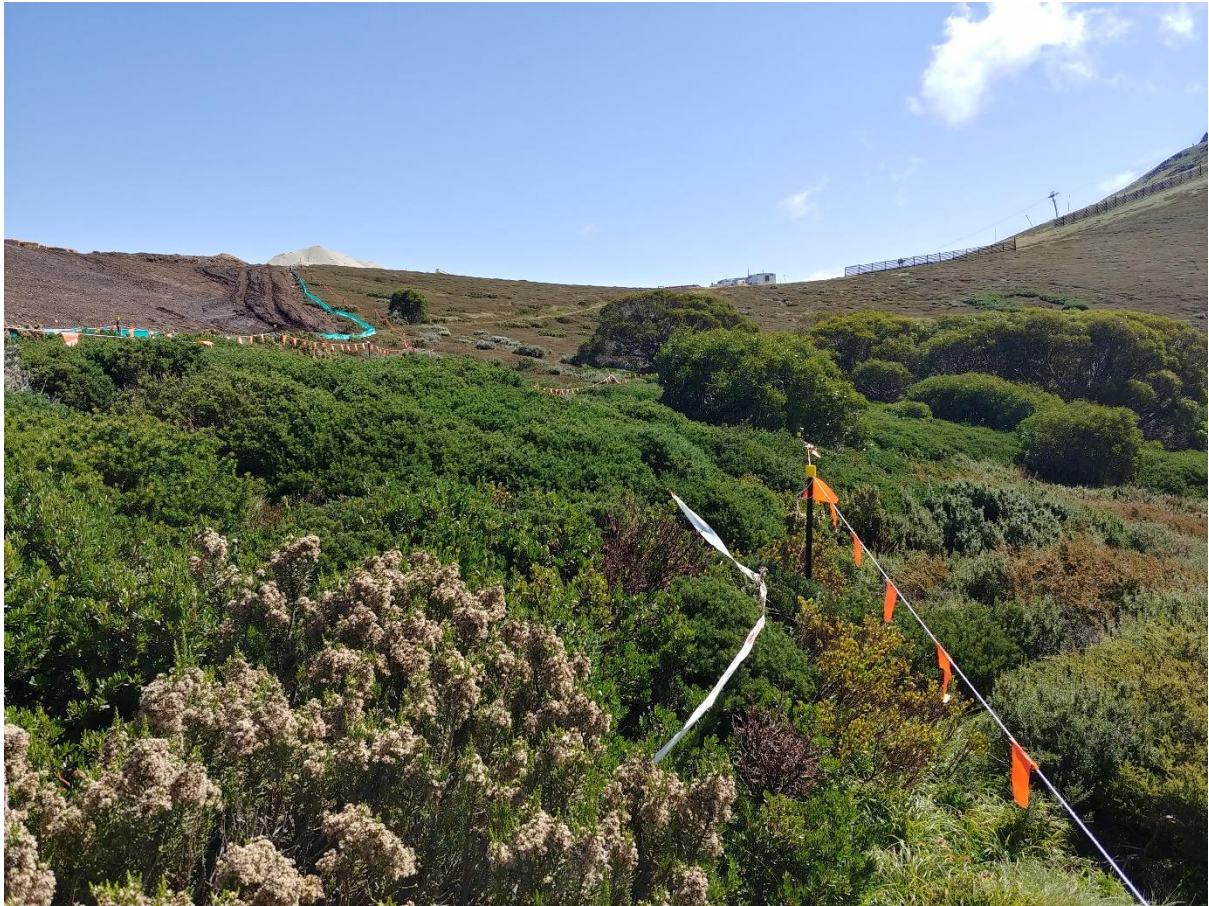
Micrositing — During the site meetings, some additional information about micrositing was provided. RMB and an ecologist from Biosis undertook micrositing pre-construction, on the 8 and 9 October 2019. Example photos were provided by ARV (e.g. Figure 7).

Figure 7. Example of micrositing (provided by ARV).

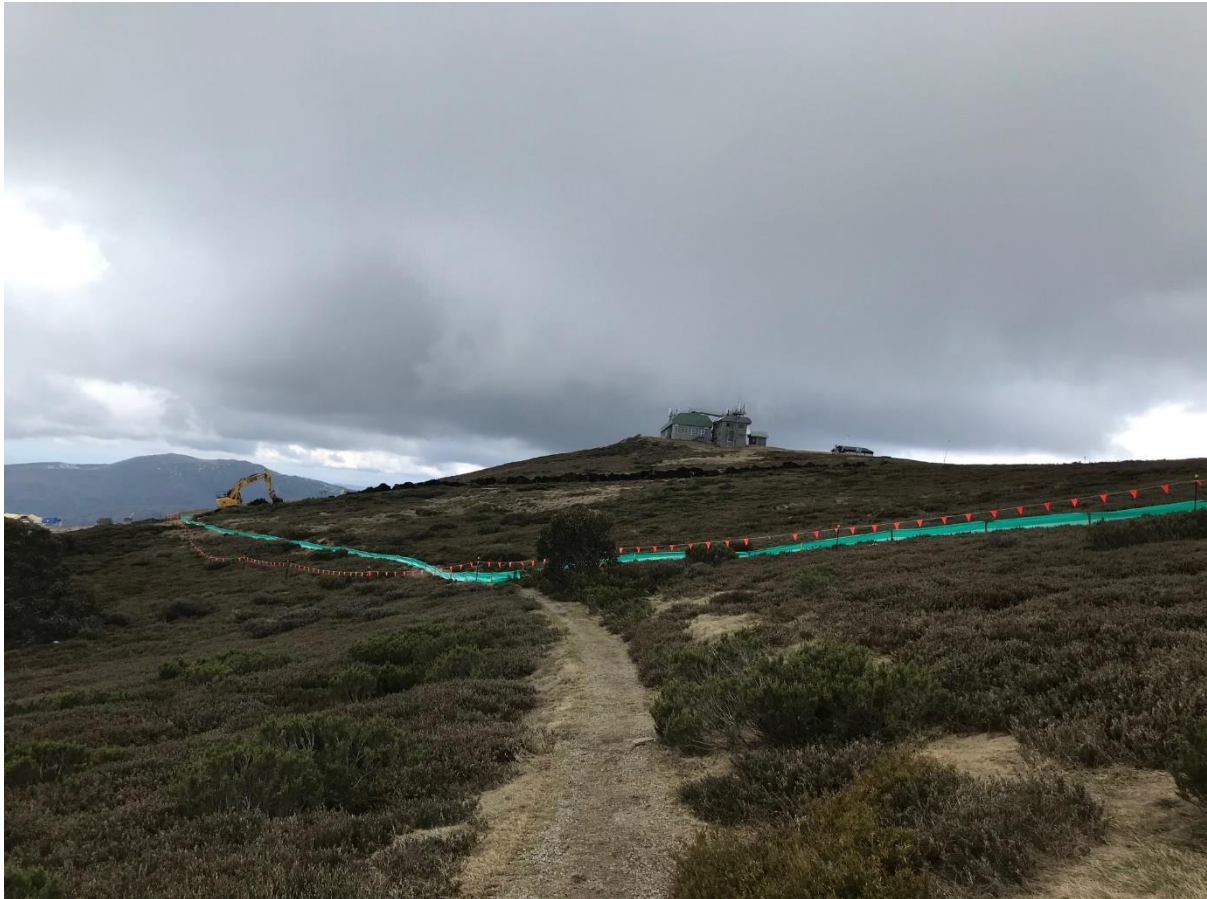
Safety bund — During the site meetings, additional information related to the safety bund was created provided. The safety bund was installed after some initial rocks had rolled from the site, over the sediment fence into the Alpine Bogs. ARV, Biosis and the regulators agreed these rocks should be left in situ, as removing them would create more damage. Photos of the safety bund installed after this initial rock fall were provided by ARV (e.g. Figure 8).

Figure 8. Safety bunding installed during the dam construction (provided by ARV during the site visits).

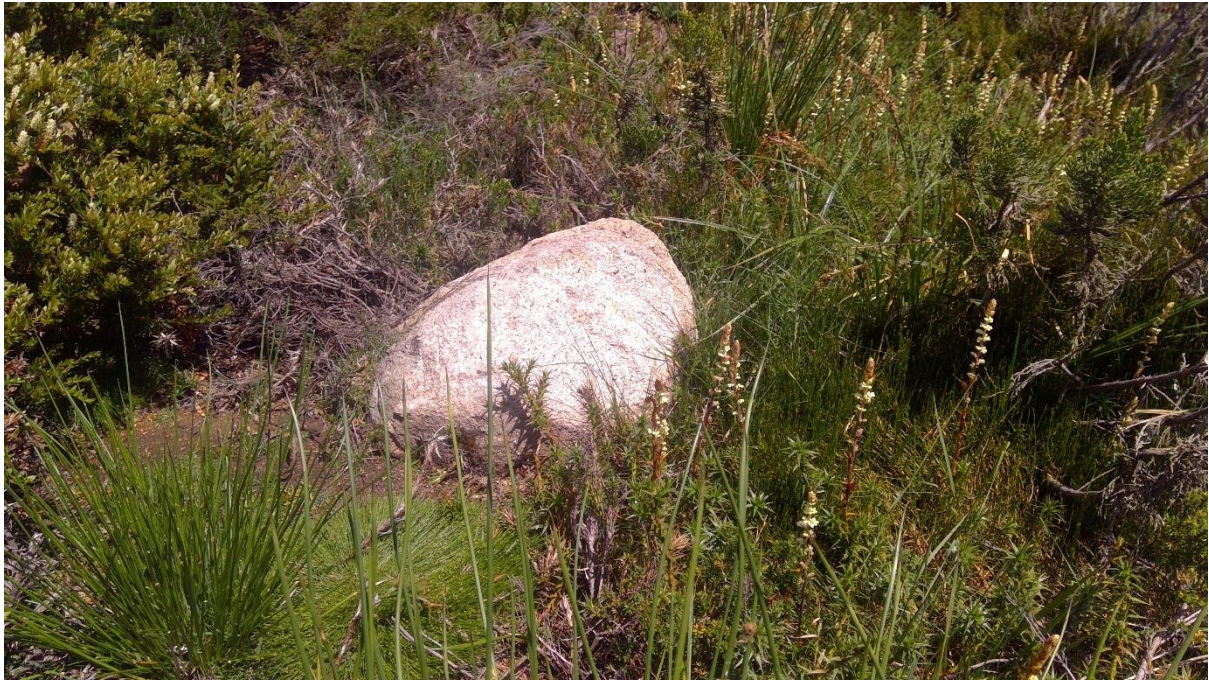
Weed management — Several environmental weeds including introduced *Juncus* species were observed scattered along the upper edge of the indirectly affected Alpine Bogs and along the aqueduct (e.g. Figure 8). During the site meetings some additional information about weed management was

Figure 9. Rock encroachment and point of sedimentation and weed establishment observed on the upper edge of indirectly affected Alpine Bog 11.2.

R3 – Maintain or replace sediment control measures where sediments, rocks and weed propagules are entering bog areas from upslope. Timing – ongoing.

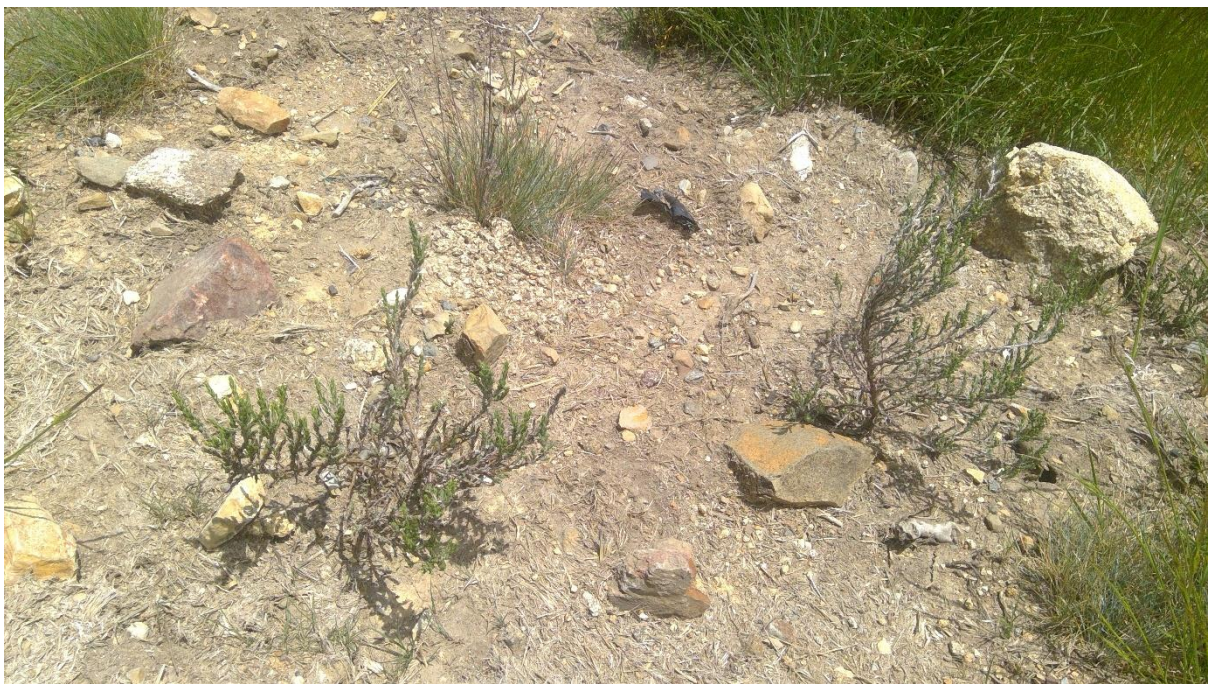
Revegetation — Some revegetation was observed along the southern edge of indirectly affected Alpine Bog 4.2 (e.g. Figure 10). Some 'bare ground' was observed within the indirectly affected Alpine Bogs, including surrounds planted tubestock (Figure 10) and in areas where sedimentation has occurred (e.g. Figure 9). During the site meeting, additional information was provided related to the revegetation of the dam and surrounds, post-construction. There are two rehabilitation plans: the Ecological Rehabilitation Plan, and the Addendum. The Addendum is focused on addressing impacts associated with non-compliances in the indirectly affected Alpine Bogs. The ARV has implemented the Ecological Rehabilitation Plan since construction of the dam was completed. This includes planting 15,000 tubestock per year onsite. Another 15,000 plants are arriving onsite on 8 March 2023, with an additional 2500 for the indirectly affected Alpine Bogs. Creative Lines are contracted by ARV to provide independent annual monitoring reports on progress of Ecological Rehabilitation Plan implementation. The 2022 Ecological Rehabilitation Plan Monitoring Report was provided as an example.

Figure 10. Revegetation along the upper extent of indirectly affected Alpine Bog 4.2.

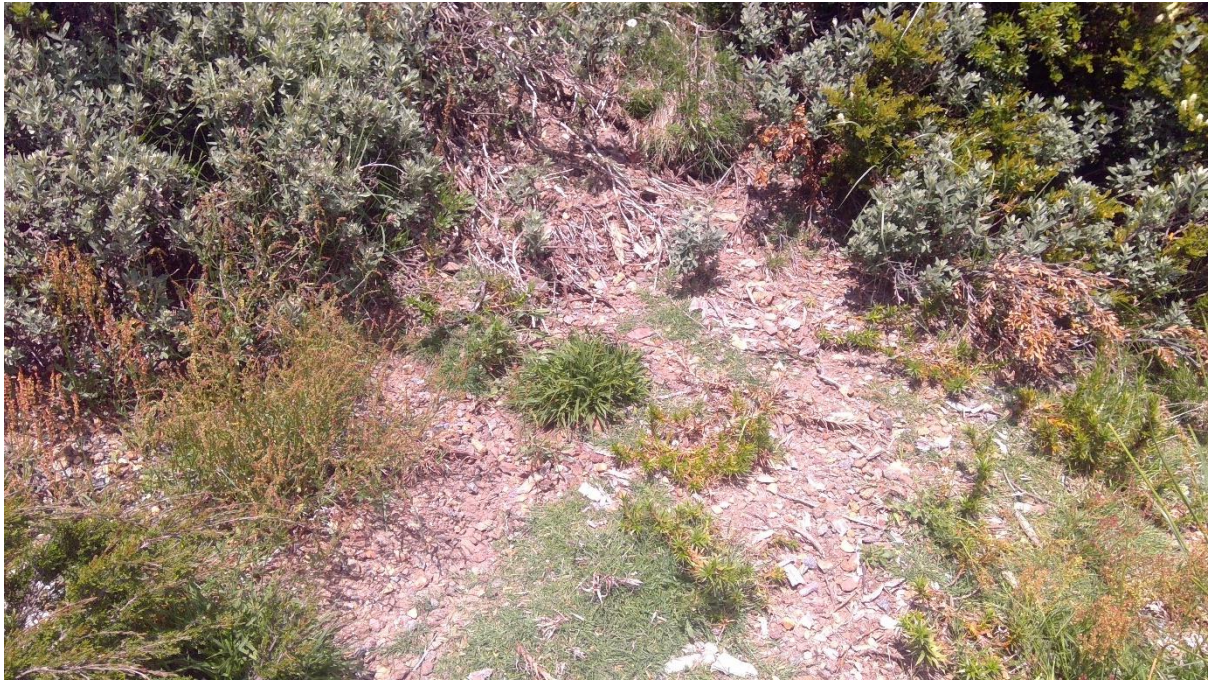
Water quality remediation — Several observations related to sedimentation and water quality remediation were made during the site visit. Evidence of past sedimentation was observed along the southern edge of indirectly affected Alpine Bog 11.2 (Figure 11) and within the aqueduct (Figure 4). Sediment controls observed included a fence installed along the southern edge of some indirectly affected Alpine Bogs (e.g. Figure 12), along the edge of the track which runs along the northern edge of the dam (Figure 6) and within the drainage lines installed beside the dam (Figure 3). During the site meetings, some additional monitoring information was provided. Sediment controls are monitored weekly (data on a spreadsheet) and reported monthly to Alpine Planning – formerly Department of Energy, Environment and Climate Action (DEECA), now Department of Transport and Planning (DTP).

Figure 11. Evidence of past sedimentation on the southern edge of indirectly affected Alpine Bog 11.2.

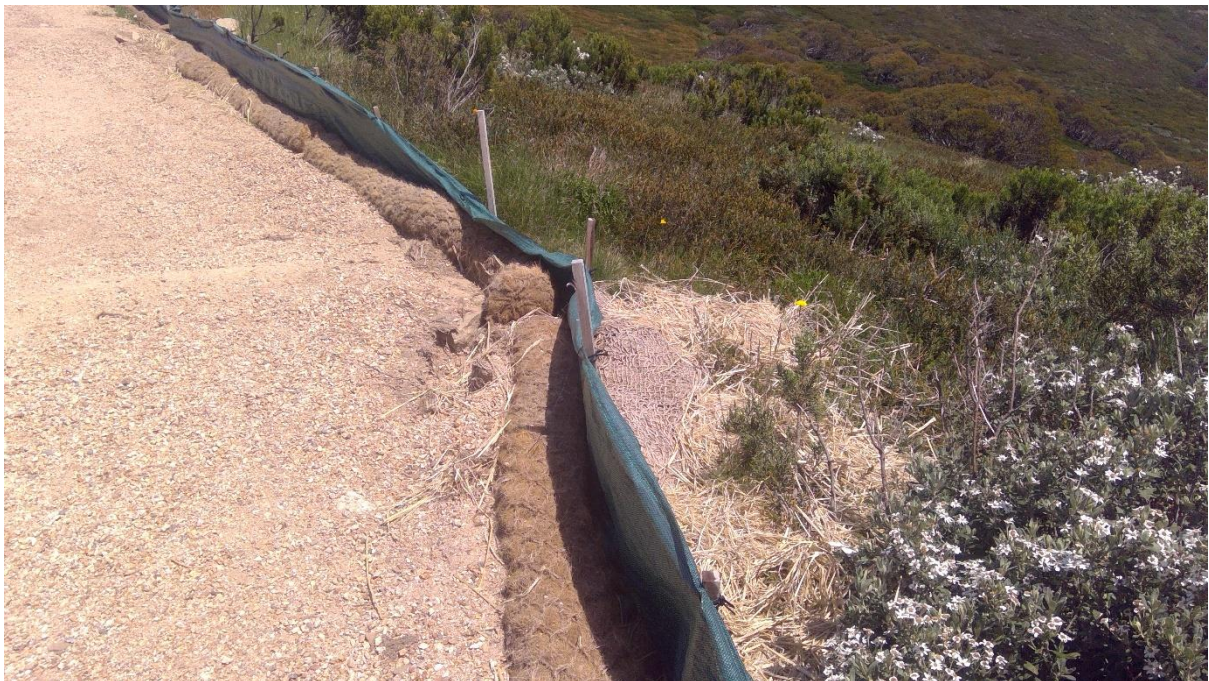
Figure 12. Example of sediment controls installed above the indirectly affected Alpine Bogs.
